A small example from *Bridge, design & engineering* magazine
Fourth Quarter 2019 to whet your appetite!

RISE OF THE ROBOTS

Engineers carrying out close-up inspection of the world's longest suspension bridge in Japan have trialled a new robotic inspection unit which is considerably smaller and lighter than the prototype.

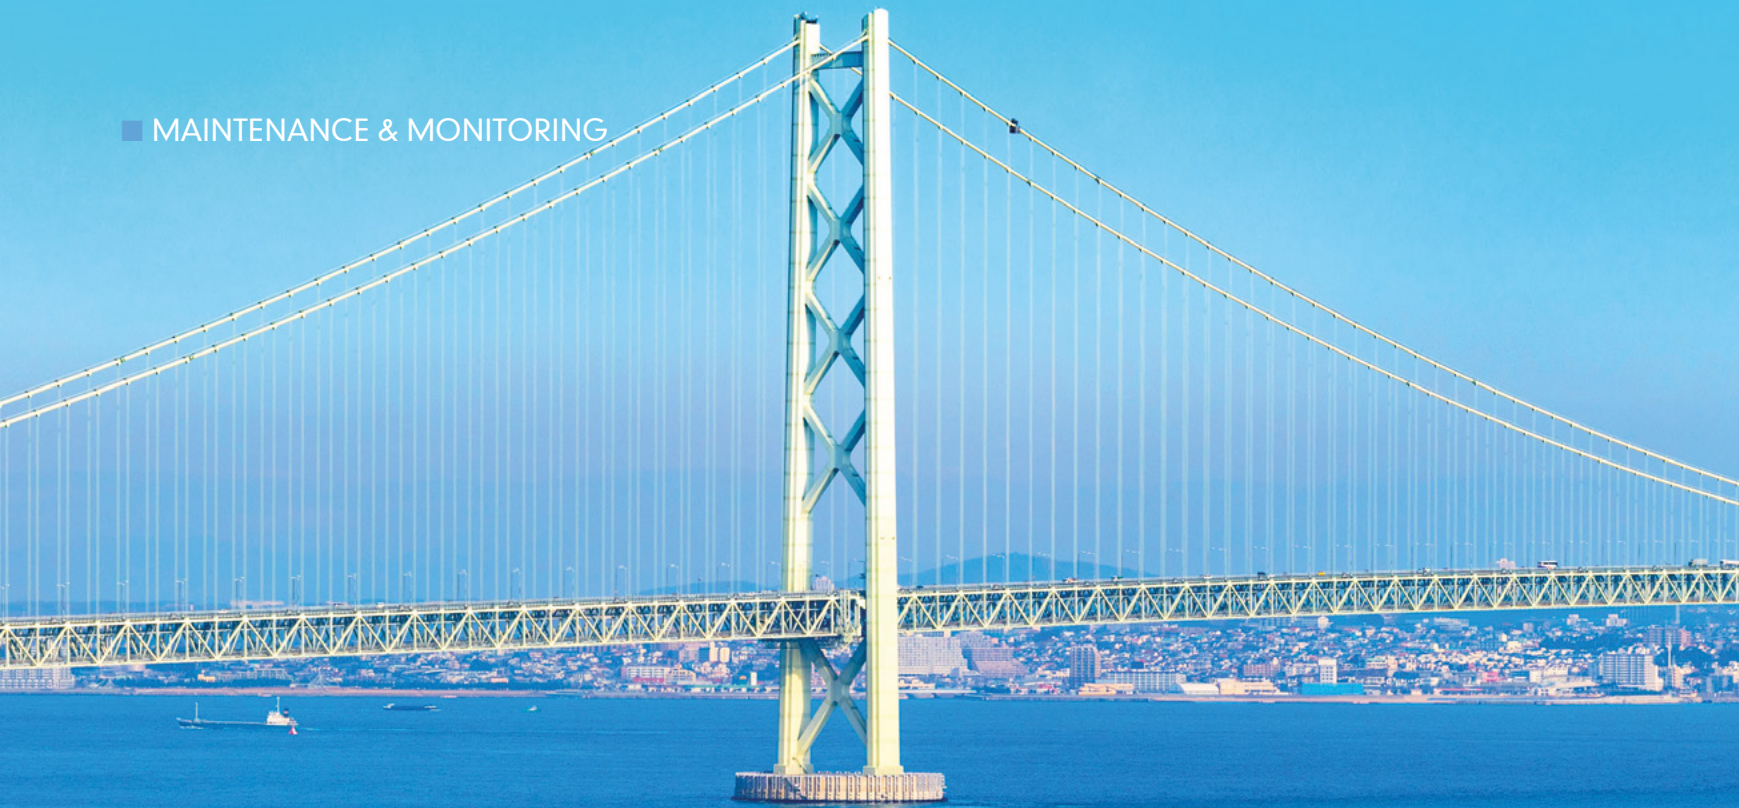
A second-generation robotic inspection unit that only weighs 83kg (opposite) was successfully deployed on the Akashi-Kaikyo Bridge last summer (Shutterstock)

The new inspection unit, which was developed by the organisation and its subsidiary Bridge Engineering Company, was first trialled on one of the towers of the Akashi-Kaikyo Bridge last summer. It is just 862mm long and the whole unit weighs 83kg, but it can be dismantled into six pieces, the largest of which weighs 32kg, meaning it can be handled manually without the need for a heavy machine or specialist installation equipment. The travelling speed of the new unit is 10m/minute, twice that of the original prototype.

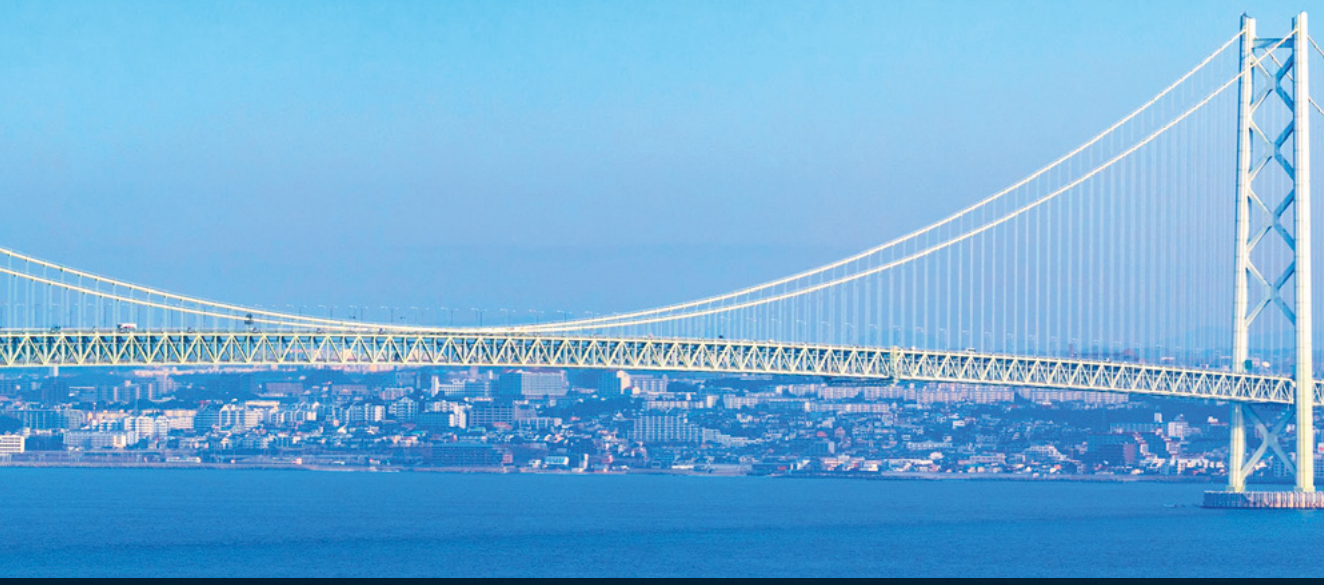
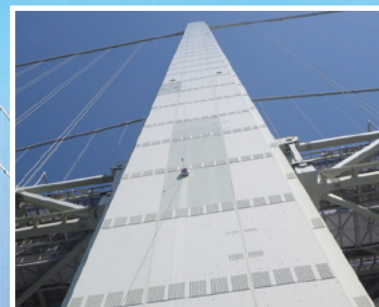
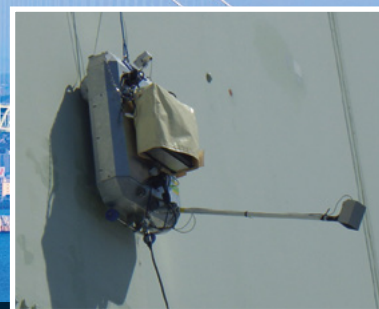
HSBEC started to develop a second generation of the inspection robot, looking to create one which was still able to carry out close inspection by use of a camera but was smaller and lighter to improve handling. The main challenges were how to reduce its size and weight while still enabling it to negotiate the joints on the outer surface of the steel towers, where the structural elements were connected by high-strength bolts. The maximum size of the obstruction is 43mm: 22mm thickness of

splice plate thickness plus 21mm of the bolt head.

The robot has magnetic wheels, which allow it to stick to the vertical surface of main tower, and it is capable of traversing the bolted splice plates which occur at 10m intervals, where the main tower elements are connected. It has a scraping tool attached to a multi-joint manipulator with five degrees of freedom and coating equipment that is operated from the ground. Safer and easier inspection work are possible, as well as local repairs even up to 300m above the ground.

The main change that allowed the robot to be made smaller and lighter was to eliminate the repair function and focus entirely on the inspection work. The design of the body and the magnetic wheels was optimised, which also reduced its size. Although the travelling speed of the robot is about the same as that of the gondola, its ability to move independently means that it can complete inspections more quickly.

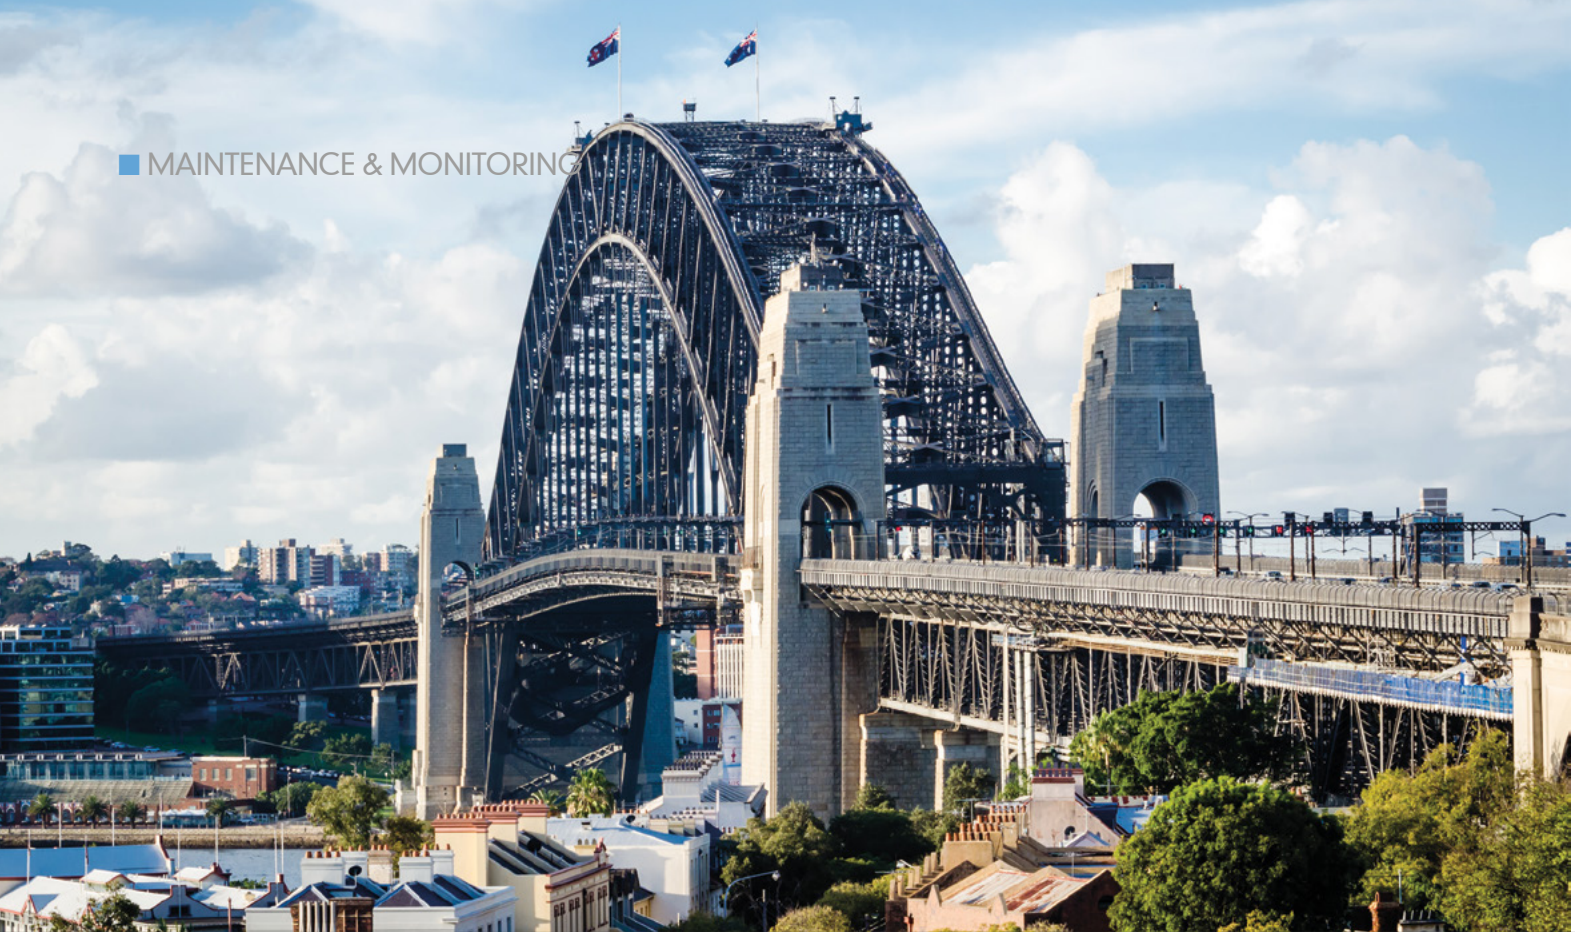
The Sydney Harbour Bridge is a vital part of the city's infrastructure, carrying over 160,000 cars per day (Shutterstock)

The steel structure was originally coated with lead-based paint, which is now deteriorating and being replaced with modern, longer-lasting and more environmentally friendly paint. Removal of paint and corrosion is traditionally carried out using power tools and sandblasting, but these are physically demanding and put staff at risk of injury. Furthermore, some parts of the bridge are not accessible with such equipment – in fact many are barely accessible even by operatives. Now, however, a three-year project funded by the Australian Research Council is bringing together engineers at Roads & Maritime Services with researchers at the Australian National University to develop a special attachment that can be used for carrying out laser cleaning inside the structure. The team is going to start by testing the latest laser cleaning technology to find out whether it is suitable for use on a historic steel structure.

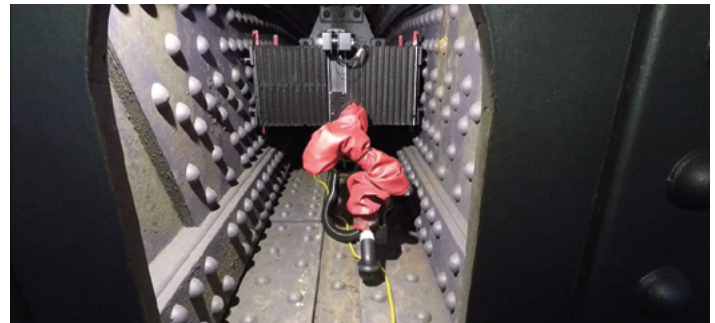
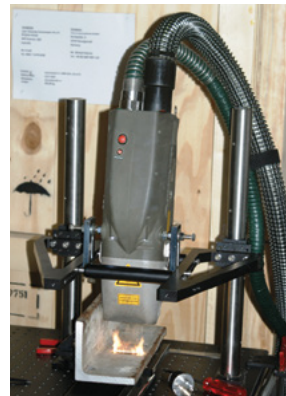
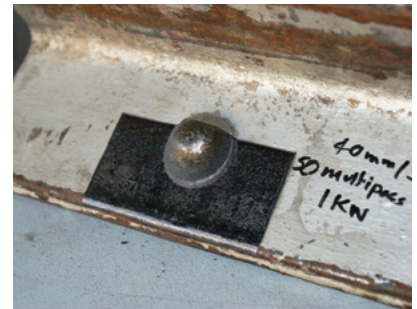
Anti-clockwise from top; Waumbot in vacuuming mode in the girder; laser cleaning equipment in action; results following laser cleaning test

Separate dust extractors will filter the air, although the laser head has a small vacuum that will clean the air locally where the laser strikes the steel. The robot will vacuum larger particles that fall to the floor and will blow down the steel surfaces prior to painting.

Once the laser cleaning process has been developed and tested, the next stage will be to develop a special attachment that can be mounted onto Waumbot, the bridge maintenance robot that RMS and the University of Technology, Sydney developed over the last decade, and which is already in use on the bridge. This will enable the laser cleaning process to be applied to the internal walls of the steel members. The same technology is planned to be applied on the external parts of the structure, using hand-held lasers.

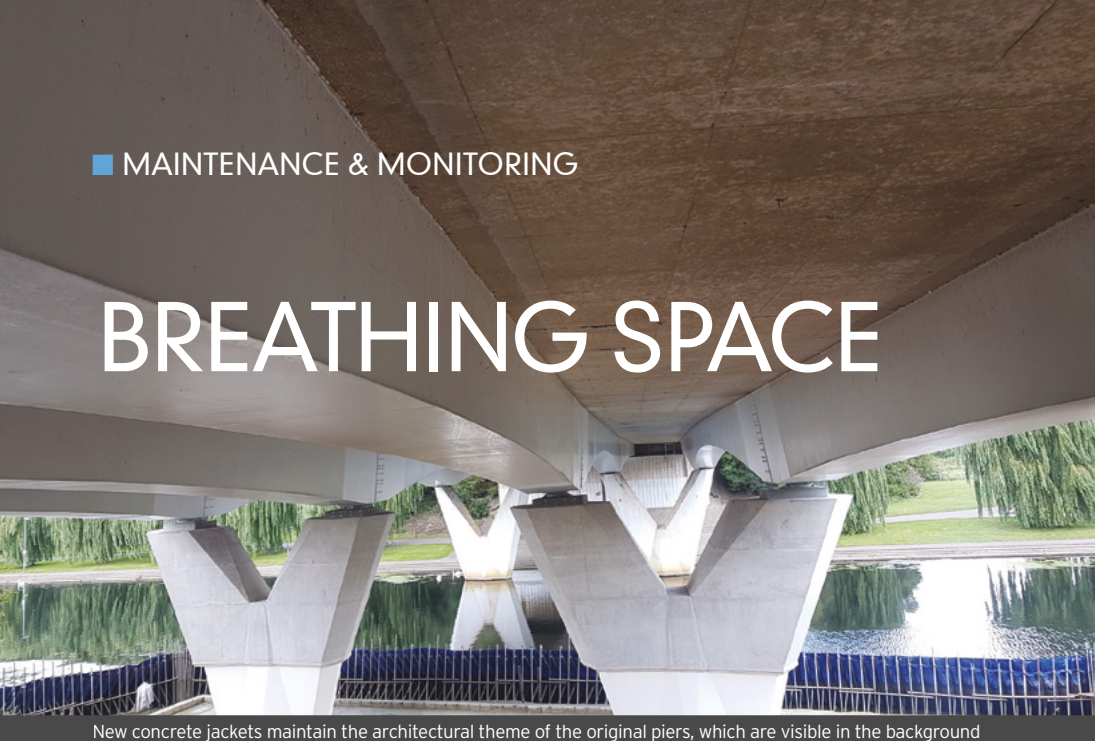
New concrete jackets maintain the architectural theme of the original piers, which are visible in the background

The solution proposed involved constructing reinforced concrete jackets around each of the piers, enabling the bearing replacement work to take place with an upgraded upper surface area of around 6.5m², while also strengthening them.

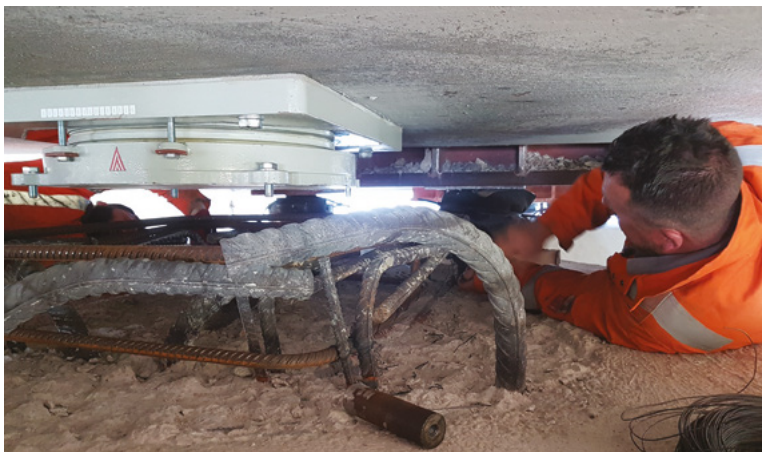
The concrete jackets provided sufficient room for the installation of the temporary supporting steelwork and jacking systems

In April this year the extensive design and installation of temporary works began. These enabled the bridge to be jacked by 3mm and the existing bearings to be replaced in stages using bespoke jacking frames bolted and welded through the main box girders.

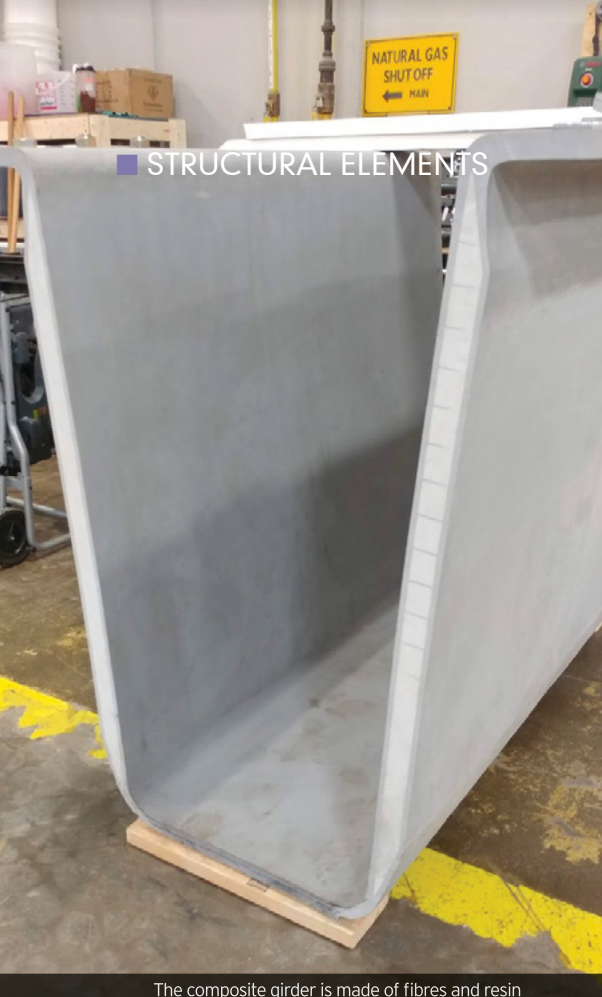
The composite girder is made of fibres and resin

According to Ken Sweeney, president and chief engineer of AIT Bridges, there are numerous benefits to using FRP for girders over concrete and steel: "First and foremost is the durability of FRP members. FRP is a corrosion-free and fatigue-resistant material, which is a vital aspect in bridge design. Second is the ability to engineer the material to the specific demands of each structure. By altering fibre types and matrix materials we can engineer a more economical design with better efficiency," he says.

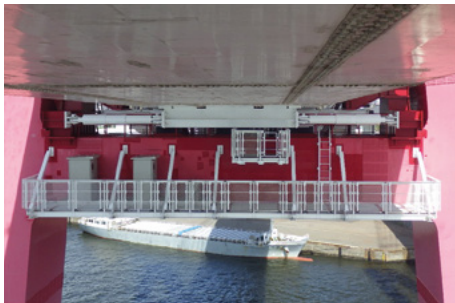
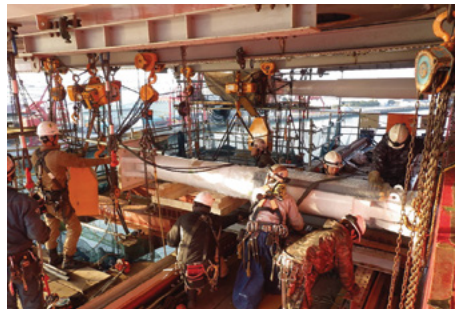
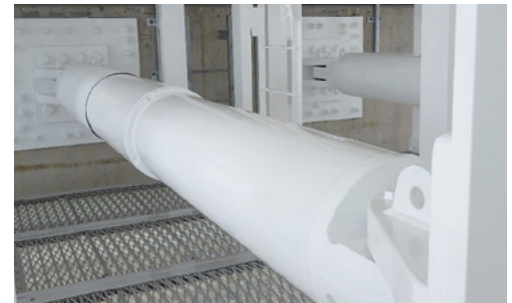
Retrofit of transversal (*above and centre*) and longitudinal (*right*) viscous dampers on the Meiko West Bridge

The installation of seismic isolation bearings and viscous dampers to reduce the demands at the structural elements by absorbing seismic energy was found to be the most effective solution. They allow the control of bridge response to strong earthquakes, the reduction of stresses of the towers below yield point, the minimising of stiffening works at the girder, and a drastic reduction in the displacements of the girder, avoiding pounding adjacent structures. Seismic isolation bearings were installed in the Meiko West Bridge to replace the existing bearings in the towers, and viscous dampers connect the deck and the substructure in both longitudinal and transverse directions to distribute horizontal inertial forces among the piers and to absorb seismic energy.
