A small snippet from *Bridge, design & engineering* magazine  
Third Quarter 2018 to whet your appetite!

# IRON WORKS

# READY FOR TAKE OFF

## Design of a new bridge on a highway in Turkey has had to address the fact that the piers of the structure will periodically be submerged in water

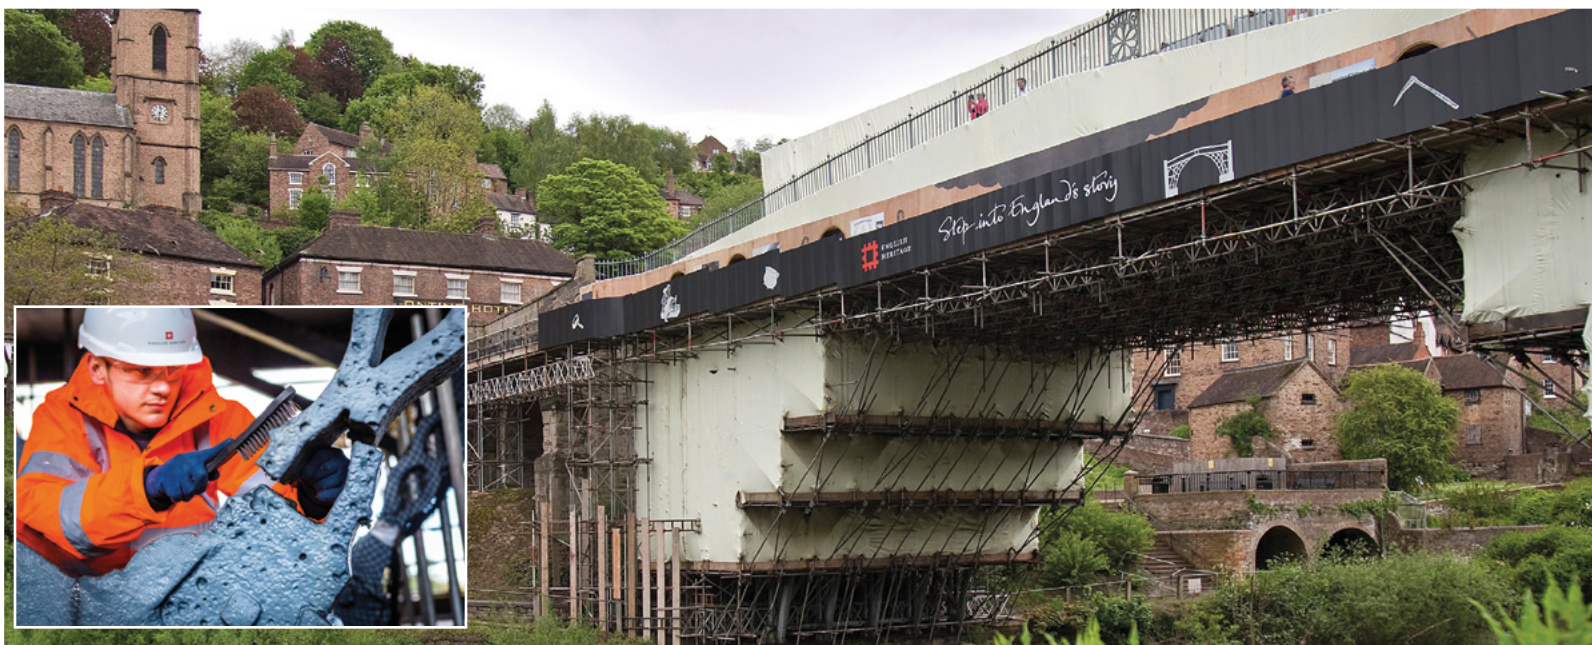
Although the bridge was fully enclosed for the refurbishment work, a walkway built alongside let visitors observe work through special portholes. Inset: detail of one of the iron members

The walkway provides access along the side of the bridge, just below deck level, and the plywood hoardings have windows cut at intervals along the bridge span, letting the public see into the work zone between the bridge superstructure. The walkway is accessible every day of the week, and visitors can also book guided tours into the work zone.

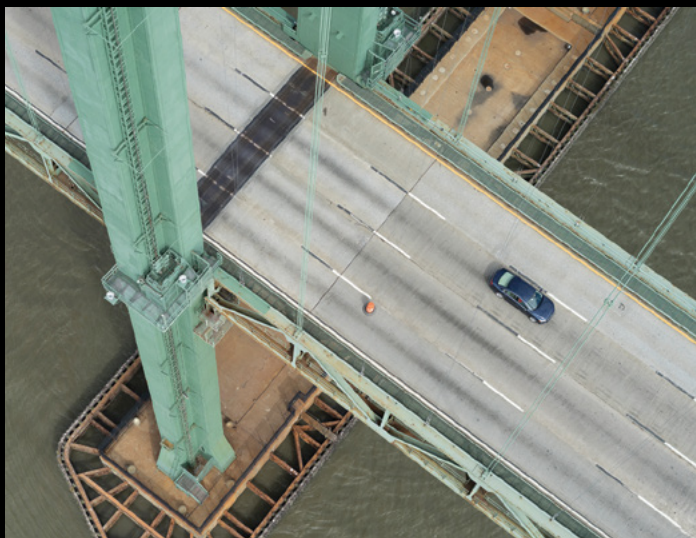
UAVs have been used on the Delaware Memorial Bridges since 2015

UAVs have been used for bridge inspections of the Delaware Memorial Bridges since 2015. These twin suspension bridges over the Delaware River connect the states of Delaware and New Jersey, and are subjected to a rigorous annual inspection programme. The Delaware River & Bay Authority is responsible for the

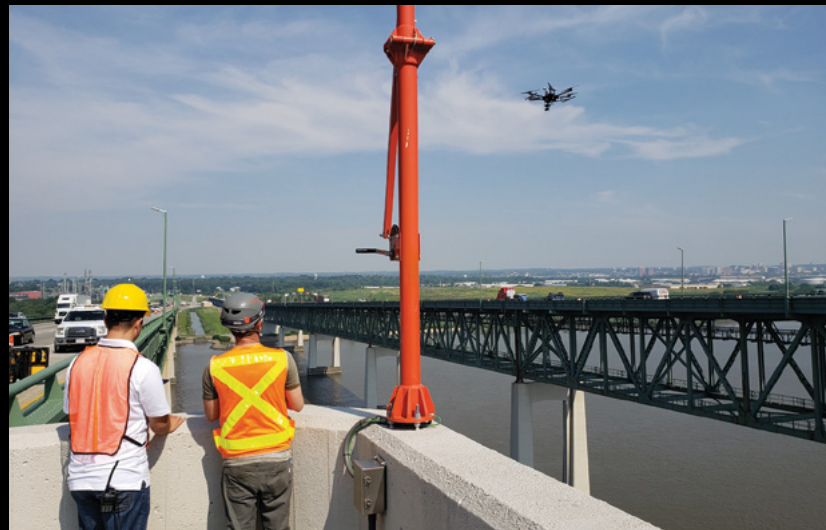
Each trial inspection has fed into further development for the technology

Stepping through these numerous trials has not been without its challenges. Caged drones used for inspections within the framing of the steel superstructure were observed to lack adequate stability to provide high-quality deliverables. The live video feeds from drone-mounted cameras, while clear and rich in detail, could only be obtained for limited time intervals due to the battery life of the

small drones being eight minutes or less. The 3D point cloud mapping of massive anchorages at the ends of suspended spans contained parts that were not as detail-rich as the rest of the structure, and the semi-autonomous and autonomous flights delivered images taken from locations that, due to wind and UAV instability, varied slightly from programmed flight-path locations.

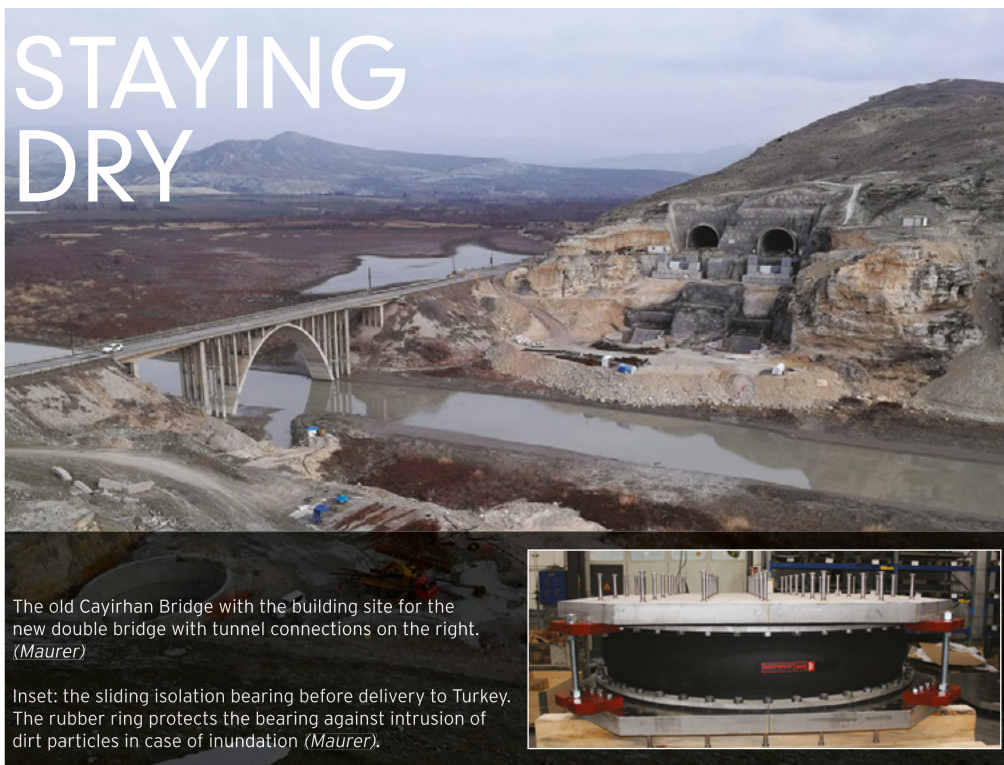
The old Cayirhan Bridge with the building site for the new double bridge with tunnel connections on the right. (Maurer)

Inset: the sliding isolation bearing before delivery to Turkey. The rubber ring protects the bearing against intrusion of dirt particles in case of inundation (Maurer).

The Maurer sliding isolation pendulum fulfills four tasks in the event of an earthquake: transferring vertical loads of up to 56MN, isolating the bridge deck from the foundation and allowing horizontal displacements of  $\pm 157\text{mm}$ ; they dissipate seismic energy through friction and they return the bridge superstructure to the central position after an earthquake, thanks to the concave, curved sliding plate.

The single-sided movable sliding pendulum bearings contain a calotte as a tilting element with the upper surface slightly curved. This calotte is manufactured from Maurer Sliding Alloy - a particularly corrosion-resistant metal alloy developed by Maurer. In the event of bridge movements, this calotte slides horizontally in the concave sliding plate with a pendulum motion, and by this means, the bearing automatically returns to the centre in an earthquake by storing potential energy.
