Hidden bridge defect investigation and monitoring

A definitive approach to managing hidden defects in bridges.

BridgeWatch® in action

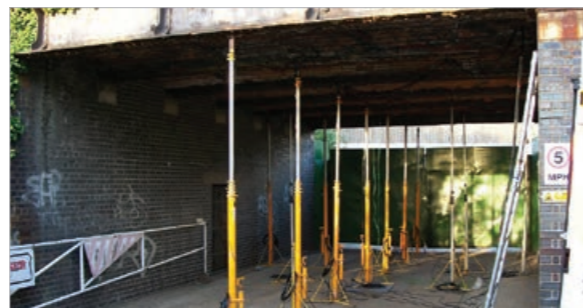
Location: Trowse Bridge and Caerphilly Station

Hidden defect: Deck plates, jack arches

Problem: The degree of load transfer from the deck plates to longitudinal beams was unknown, causing assessment calculations to call for a weight limit to be imposed on the bridge.

Solution: James Fisher Testing Services completed controlled static load testing. The use of known weights combined with the measurement of displacement and strain enabled more accurate assessments to take place at the site.

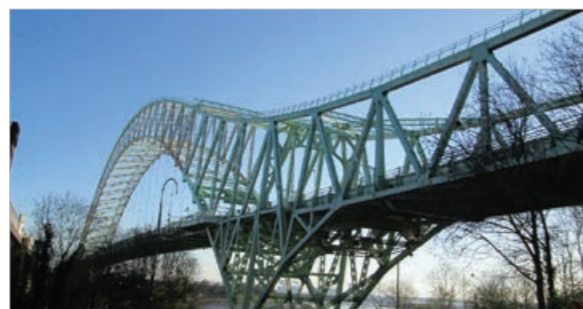
Location: Silver Jubilee Bridge, Newcastle HLB (CS7)

Hidden defect: Suspension bridge hangers

Problem: The client wanted to conduct load measurement testing on the bridge's suspension hangers.

Solution: A programme of load measurement on the hangers of the bridge was undertaken using vibration measurement techniques in order to accurately confirm the dead load condition.

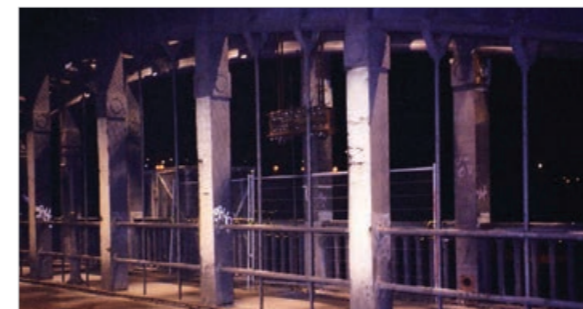
Location: Newcastle High Level Bridge

Hidden defect: Compression members

Problem: The client required data relating to the load upon cast iron compression members / wrought iron (hidden) hangers.

Solution: James Fisher Testing Services was employed to monitor the loads within cast iron compression members and wrought iron (hidden) hangers before and during hanger replacement. The purpose was to ensure that load redistribution during hanger removal was managed safely and then to ensure that new hangers were tensioned to the correct level.

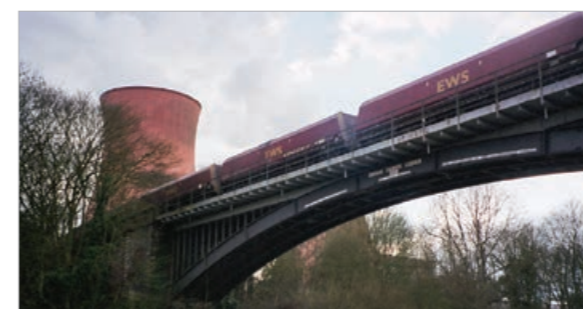
Location: Albert Edward Bridge

Hidden defect: Brittle fracture

Problem: Cracked cast iron spandrel posts.

Solution: James Fisher Testing Services set up a system to monitor a cracked cast iron arch bridge in order to determine whether the structure was further deteriorating. Cracks existed at the top and bottom of integral spandrel posts and the problem was originally managed by frequent roped access inspection. The monitoring regime substantially reduced the inspection frequency and has provided a cost-effective method for managing the problem for over 11 years.

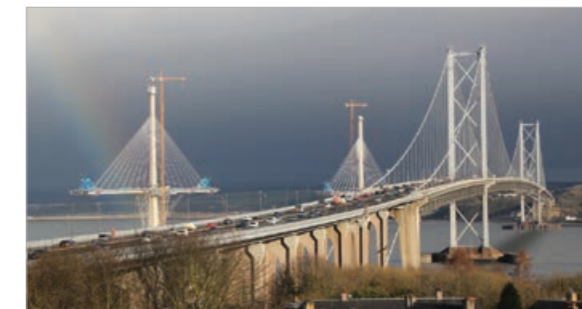
Location: Forth Road Bridge

Hidden defect: Fatigue cracking

Problem: During a routine inspection, damage to the bridge was noted. This included the complete fracture of one element of the truss end link on the mains span section of the eastern leg of the north tower of the bridge, and the partial fracture of its counterpart. The bridge was closed whilst repairs were carried out.

Solution: James Fisher Testing Services deployed a comprehensive health monitoring system to the bridge, including more than 200 strain gauges, temperature and tilt sensors to measure stress in the bridge members. This monitoring enabled the identification of the root cause of the link failure; a seized pin, and a phased repair was implemented as a result of the findings.

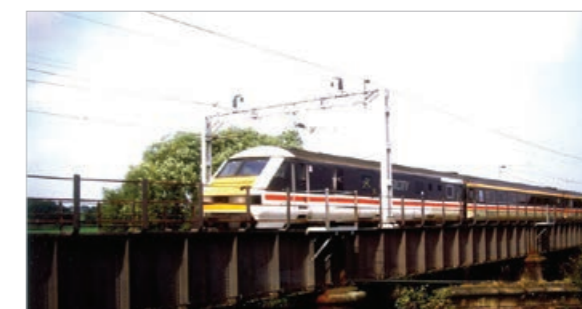
Location: Comberford Hall Bridge

Hidden defect: Bolting and rivets

Problem: The effectiveness of riveted flange plates was called into question following an assessment of the bridge structure.

Solution: The effectiveness of riveted flange plates on a multispan through girder rail bridge was monitored by James Fisher Testing Services. According to assessment codes, the lap length where plates were built up to resist bending moments was insufficient, resulting in the bridge failing its assessment. The monitoring project established that there was hidden strength and the assessment could be amended.

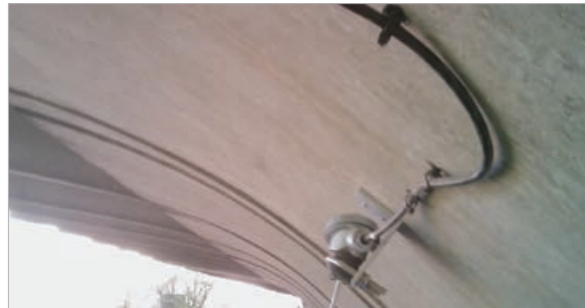
Location: A4 Hammersmith Flyover

Hidden defect: Pre-stressing wires / strands / anchorages

Problem: Breakages of post-tensioning tendons meant that residual strength testing was required to monitor the effect of failures on the structure.

Solution: James Fisher Testing Services undertook programmes of in-situ stress measurement in the post-tensioned concrete structure. This was part of the assessment of the structure's residual strength following well publicised breakages of post-tensioning tendons, as detected by acoustic emission monitoring. James Fisher Testing Services also set up instrumentation for monitoring the structure during re-stressing operations.

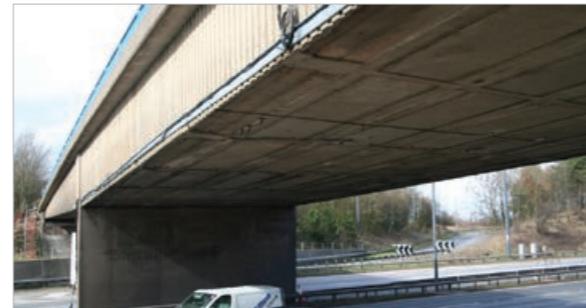
Location: M56 Bowden View

Hidden defect: Missing / inadequate rebar / pre-stressing

Problem: Risk of sudden bridge collapse.

Solution: James Fisher Testing Services ascertained the dead load condition within a segmental post-tensioned concrete bridge deck. A monitoring system was fitted to the bridge, including acoustic emission sensors to detect pre-stressing wire breaks. Strain and displacement sensors were employed to monitor potential crack development.

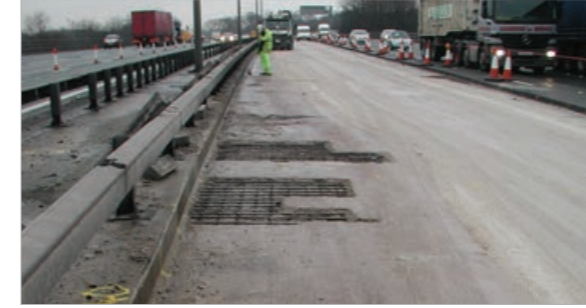
Location: M6 Lodge Lane Viaduct and Besancon Bridge, Huddersfield.

Hidden defect: Corrosion of embedded reinforcement

Problem: During resurfacing work, concerns were raised as to the condition of the exposed reinforced concrete decks.

Solution: James Fisher Testing Services conducted extensive half-cell potential measurements across the full deck areas. Colour contour plotting of the results highlighted several areas where high levels of corrosion activity were evident. Laboratory testing of incremental concrete samples extracted from these areas showed significantly high chloride values, also indicating probable corrosion activity. Removal of the surface concrete confirmed the problem with several reinforcing bars showing major loss of steel section leading to a reduction in strength.

All chloride contaminated concrete was removed and additional or new reinforcement was installed prior to concreting and re-waterproofing.

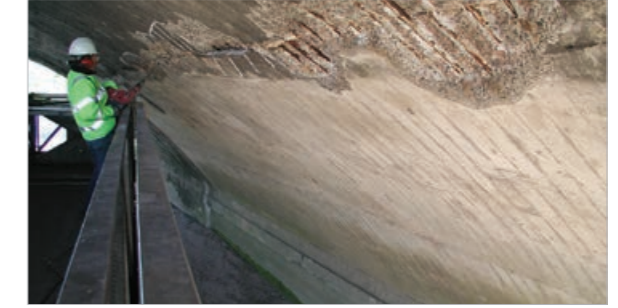
Location: Ribble Walton Bridge, Preston

Hidden defect: Concrete delamination and corroded reinforcement

Problem: General condition survey found large areas of delaminated concrete.

Solution: James Fisher Testing Services completed a comprehensive tap hammer survey to determine the full extent of the problem. Where concrete fell away the underlying reinforcement was seen to exhibit heavy surface corrosion. A full suite of testing was then carried out, including; cover depth, half-cell potential, resistivity, chloride sampling and carbonation depth testing. The cause of the problem was determined to be carbonated concrete down to the depth of the reinforcement, where reduced alkalinity had led to corrosion of the bars and subsequent concrete breakdown. All affected concrete was removed, the bars were cleaned, and spray concrete repairs were applied.

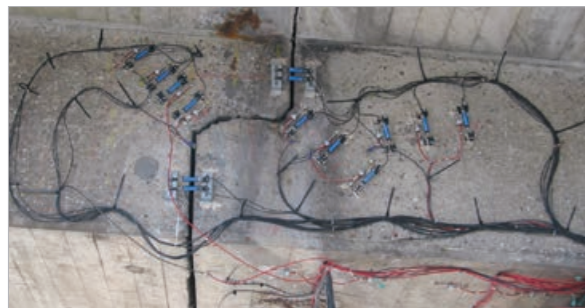
Location: M8 Kingston Bridge complex

Hidden defect: Half joints

Problem: The renewal of approach viaducts required strength testing to be carried out on existing half joints.

Solution: As part of a renewal of approach viaducts, a test to destruction of a half joint was undertaken, with monitoring by James Fisher Testing Services. This was used to provide information about any hidden strength and to give confidence about the likely condition of the dozens of other similar joints within the junction complex.

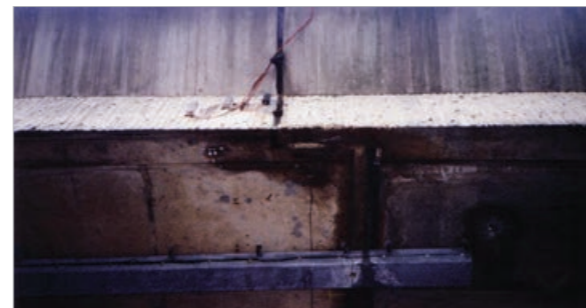
Location: A14 Huntingdon Railway Viaduct

Hidden defect: Half joints

Problem: Deformations of the concrete half joint and potential failures of hidden half joints.

Solution: James Fisher Testing Services designed and implemented a system to monitor deformations of the concrete half joint, as an indicator of impending failure of the hidden half joint.

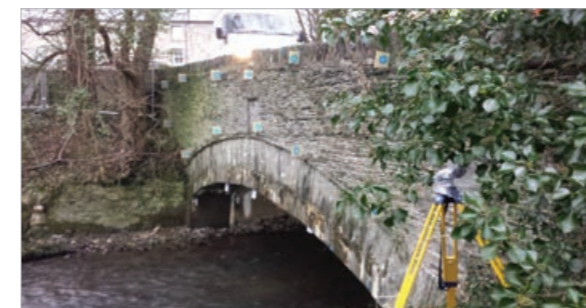
Location: Isle of Man

Hidden defect: Arch barrel

Problem: Deformations of the arch barrel.

Solution: James Fisher Testing Services implemented a camera-based system to monitor the deformation of the arch barrel under load. The resulting information gave an indication of load paths and locations of high strain, pinpointing areas where cracks could develop.

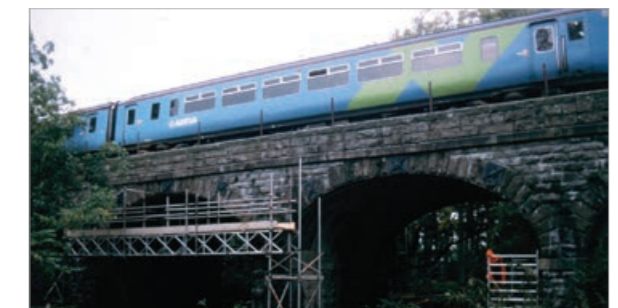
Location: Bell Busk Viaduct

Hidden defect: Spandrels

Problem: Longitudinal cracks had appeared beneath the spandrel and arch barrel interface.

Solution: James Fisher Testing Services undertook long term monitoring for deterioration and short term testing using special 3D displacement sensor arrays. These tests were used to identify whether new freight wagon arrangements were causing more distress to the structure due to a more concentrated load application.

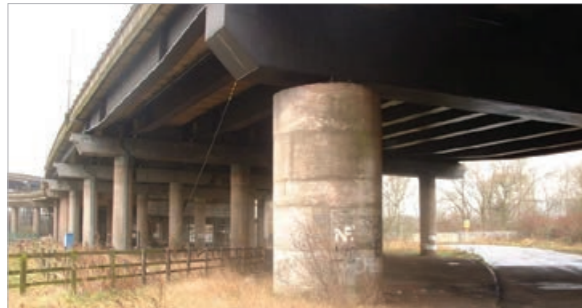
Location: M5 / M6 Midlands links

Hidden defect: Un-inspectable details

Problem: Data relating to bearing behaviour was required to plan maintenance work on multiple motorway links.

Solution: James Fisher Testing Services set up monitoring at four separate locations on the Midlands links in order to gather information about the actual behaviour of bearings and supporting structures, facilitating maintenance planning.

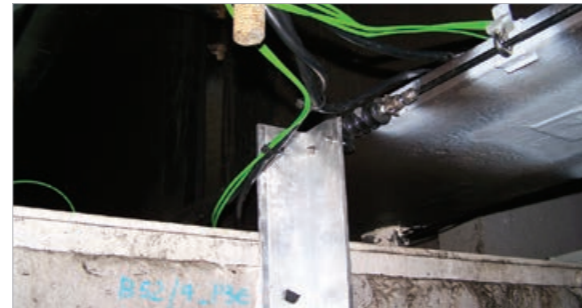
Location: M6 Bromford

Hidden defect: Bearing seizure

Problem: Data was required to measure long term structural articulation.

Solution: James Fisher Testing Services instrumented a ten span section of the bridge, enabling long term monitoring. The piers were slender and there was no evidence of movement in the steel bearings. In order to record any movement between the piers, monitoring included displacement between them so that any overall sway could be detected.

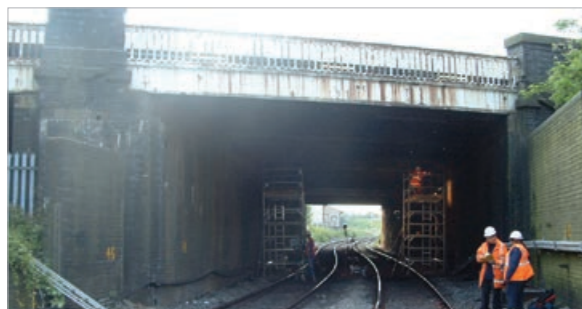
Location: Warrington Bank Quay

Hidden defect: Elastomeric degradation

Problem: Measurement of deformations in elastomeric bearings was required.

Solution: James Fisher Testing Services instrumented elastomeric bearings in order to measure the deformations in three dimensions under known traffic loading. This information was then compared with the design parameters.

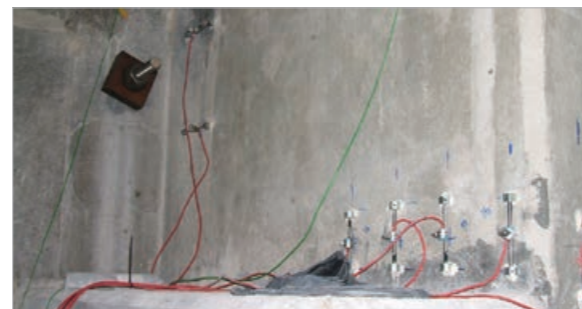
Location: A14 Orwell

Hidden defect: Setting out errors

Problem: During the 1990's a bearing replacement was completed without full consideration of deck expansion between removal and replacement operations, resulting in a misaligned bearing that was at risk of 'falling off' under extreme conditions.

Solution: James Fisher Testing Services installed instrumentation and a live camera feed to accurately measure movement within the bearing prior to its replacement.

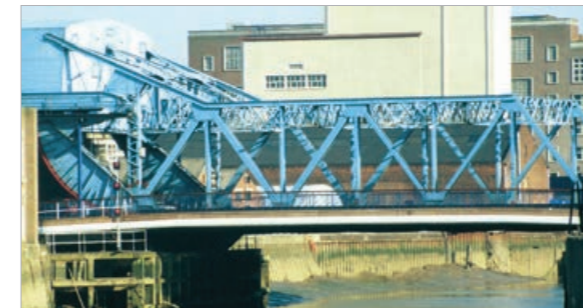
Location: North Bridge, Hull

Hidden defect: Fatigue in track girders

Problem: Longitudinal cracks were detected during a repainting contract. These were in angle sections connecting flanges to webs of the deep box section track girders, beneath the rolling part of the bridge.

Solution: James Fisher Testing Services devised a monitoring system comprising strain gauges and displacement sensors to track further deterioration and to detect whether any residual global deformations were developing. The bridge was maintained open for traffic in this condition.

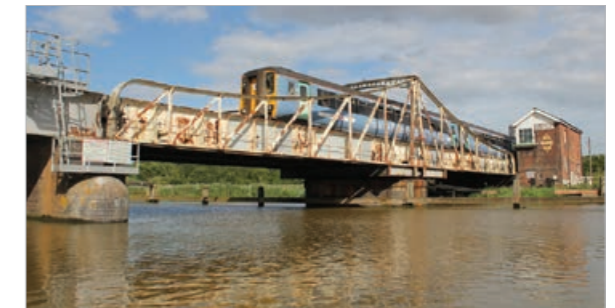
Location: Somerleyton / Reedham

Hidden defect: Articulation and load bearing issues

Problem: General structural performance.

Solution: Monitoring was implemented in order to identify how the bridge was operating and where the load paths were under trafficking.

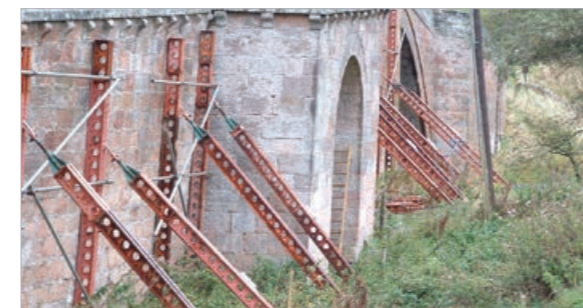
Location: Weetwood Bridge

Hidden defect: Settlement

Problem: Weetwood Bridge was suffering from leaning side walls.

Solution: The method to halt and arrest the movement involved excavation of fill from between walls and above the arch barrels; this was replaced with polystyrene fill and transverse ties were fitted. James Fisher Testing Services provided a movement and settlement monitoring system to measure any heave resulting from the removal of significant dead load.

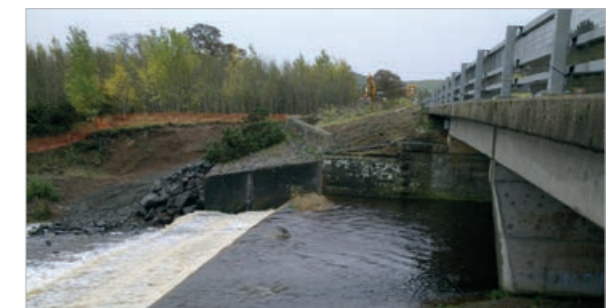
Location: Hedgeley Bridge

Hidden defect: Scour

Problem: The bridge is located across an upland river which is subject to flash flooding and fast flowing water. Scour of the bridge foundations was a concern.

Solution: The risk of scour undermining the foundations had been mitigated by the construction of a concrete apron to channel the water away from the structure. However, this was being undermined by scouring action, indicating that there remained a risk of bridge foundation scour occurring. Sensors were installed in conjunction with a solar powered data logger to monitor inclination of the concrete apron and to provide a real time alert of possible scouring.
